COAL MINE SAFETY AND HEALTH  
ROOF-BOLTING-MACHINE COMMITTEE

REPORT OF FINDINGS

July 8, 1994

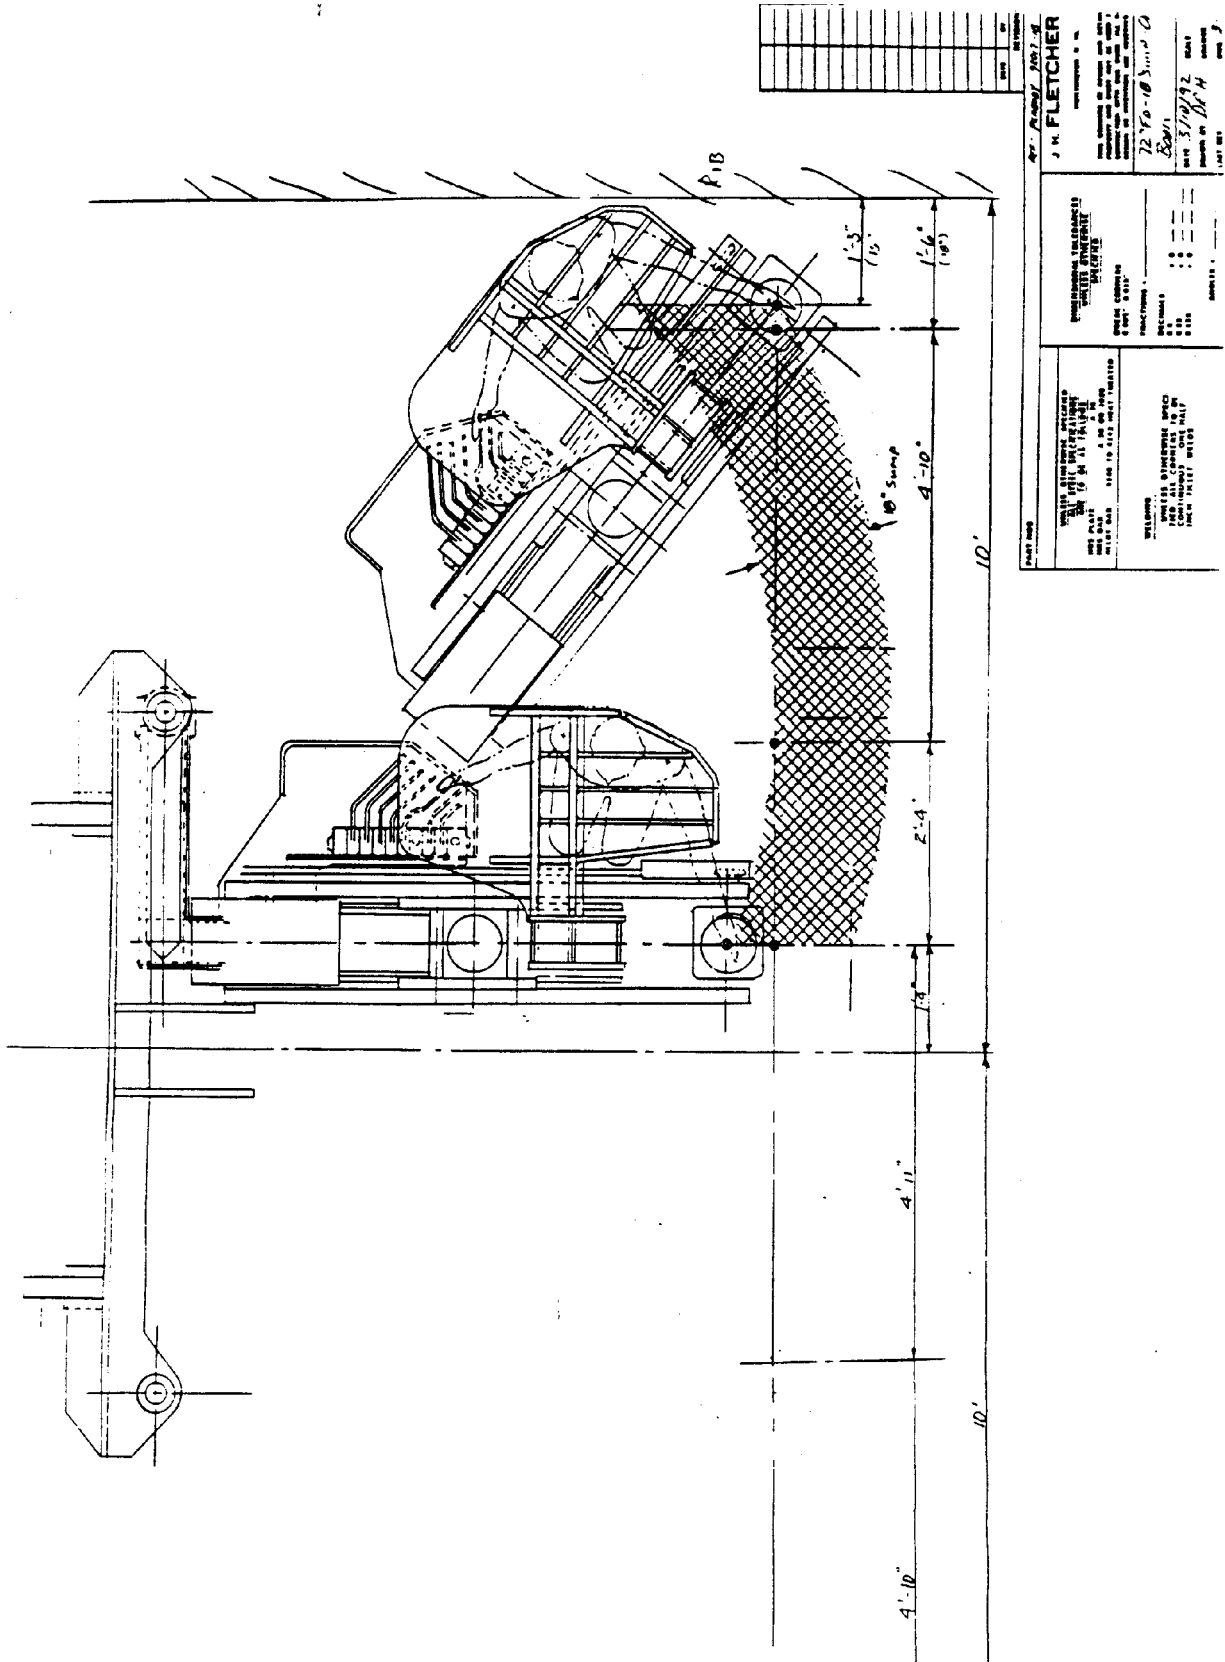
APPENDIX A

The RR-II models observed featured a relatively new drill boom arm design fabricated with an offset boom pivot point which enhances several safety aspects of the operator's work station. This offset boom arm (See Appendix A) improves the operator's access to the drilling controls. The offset drill boom also allowed relocation of the controls (compared to a standard boom layout) to a position further out by the drill head. This "streamlining" of the controls allows the roof-bolter operator to be positioned further away from the drill boom arm pinch points. A safer work position is provided while drilling holes and installing bolts and also while swinging the drill boom in order to position the head prior to bolting.
